LEGISLATIVE COUNCIL
Question On Notice

Irrigation, Crop Production and Water Management

Annual Report of 2018 Activities

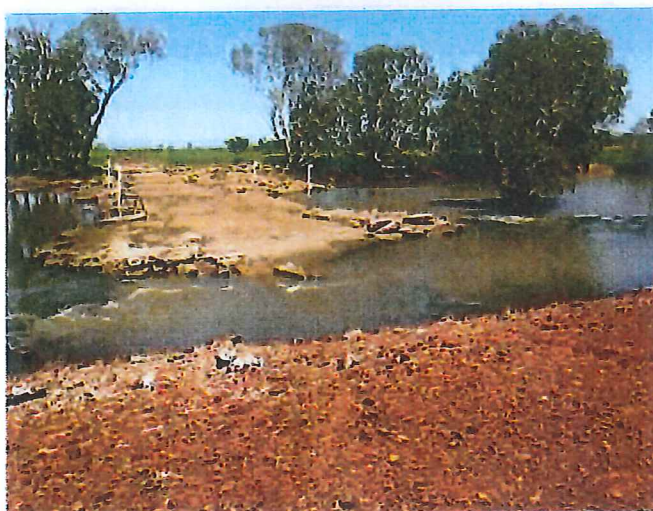
Floodway Damage

A heavy wet season in 2017/18 resulted in some useful storage of water behind the levy banks/elevated station roads on the flat area near Blina Creek, but not as significant as in 2017. The storage behind the closed floodway was the main source of water for crop production. The floodway was damaged in the 2017/18 wet season and was repaired in March 2018, as illustrated in the following pictures.

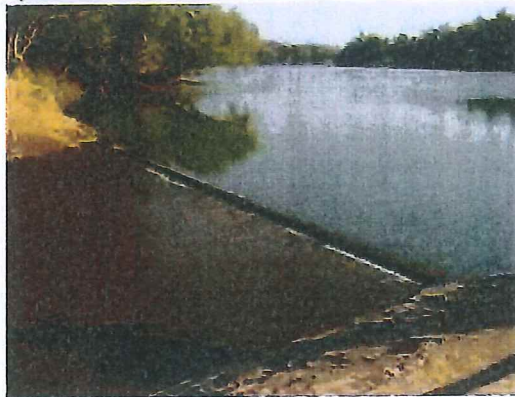
**Elevated Concrete Sill at Barrage – 2011 repair –
September 2017**

The permanent concrete sill continues to operate at the Fitzroy Barrage and was repaired during 2010. The concreted batters on the Durack Creek flume at the barrage were repaired during 2011 and the structure was in good shape at the end of the 2018 dry season. Further repairs will be made as required

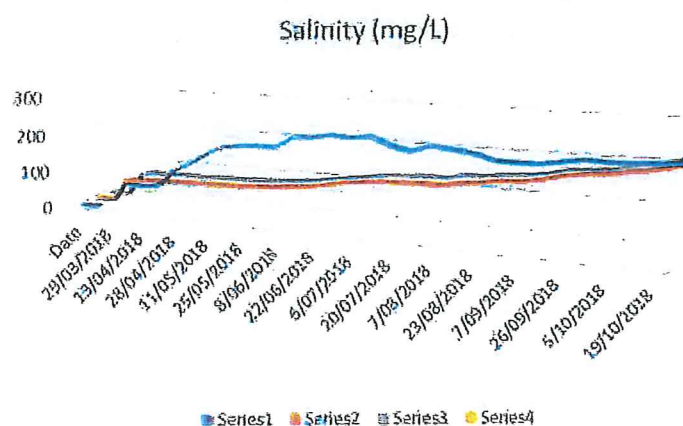
Field Salinity, Durack Pool (2018)

The electrical conductivity (salinity) in Durack Pool, as measured in the field, increased with evaporation (concentration) as the dry season progressed, from less than 100 mg/L (ppm), in March, to just over 230 mg/L at the Pivot 1 site in late October 2018, confirming very fresh water. Sampling concluded in October 2018, the last month of irrigation. All of the readings from field and laboratory analysis were of drinking water quality, based on Water Corporation standards² and there was no evidence of deteriorating water quality, a similar result to that observed from 2006 to 2017.
